# Miner County Courthouse Facilities Study

**PUETZ**  
DESIGN+BUILD

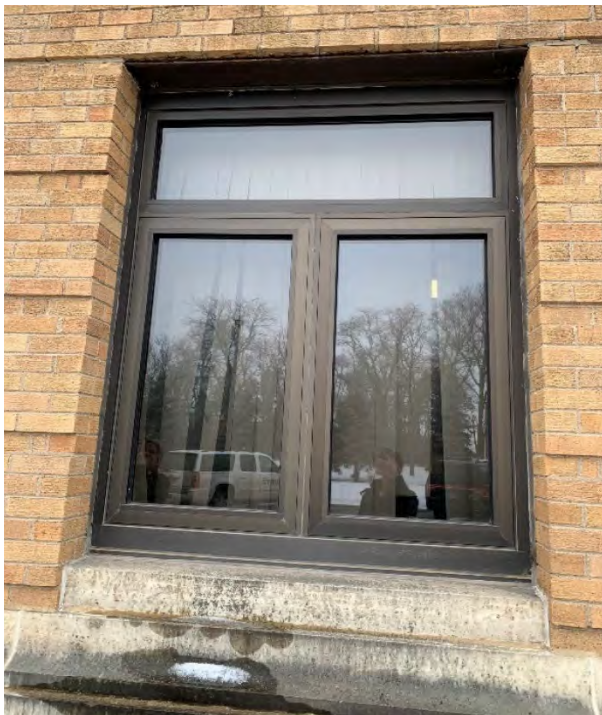
*Figure 4: exterior image of level 1 window*

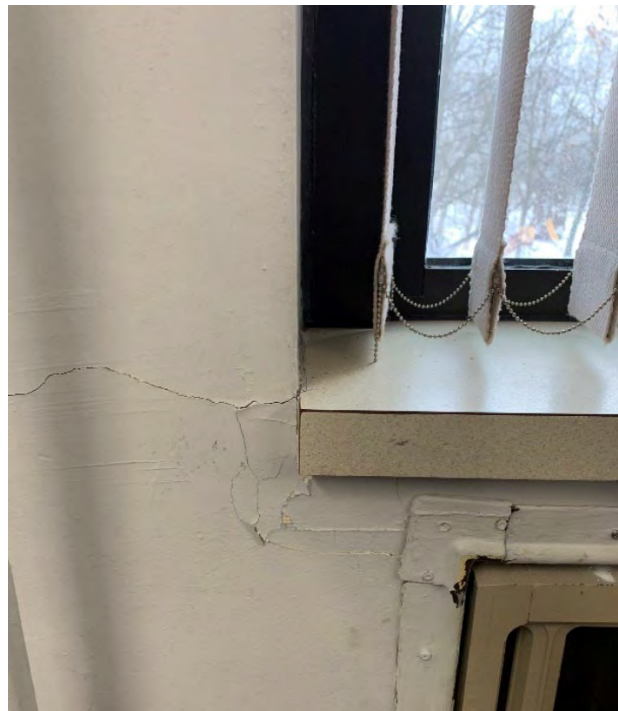
*Figure 5: water damage at window, interior*

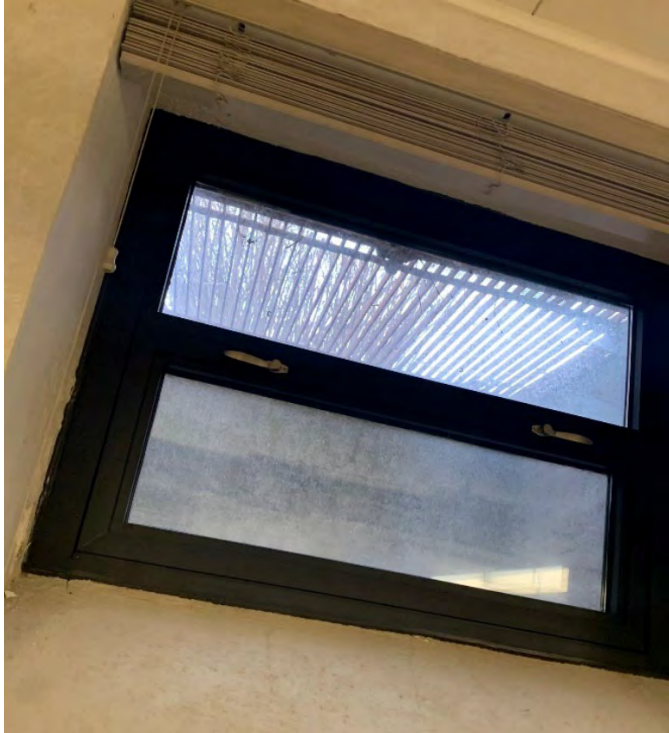
*Figure 6: window well and basement window*

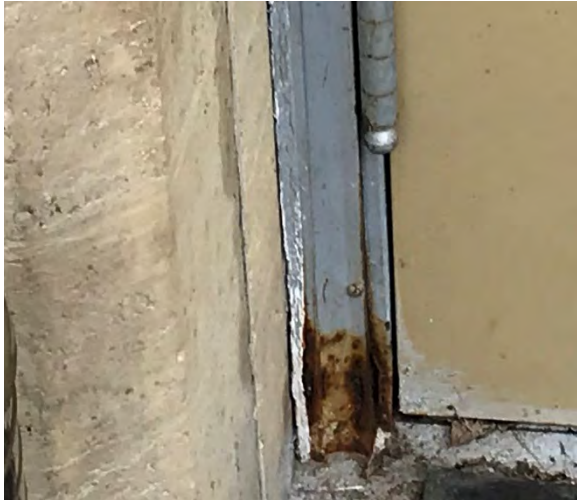
*Figure 8: rusted door hinge at North door*

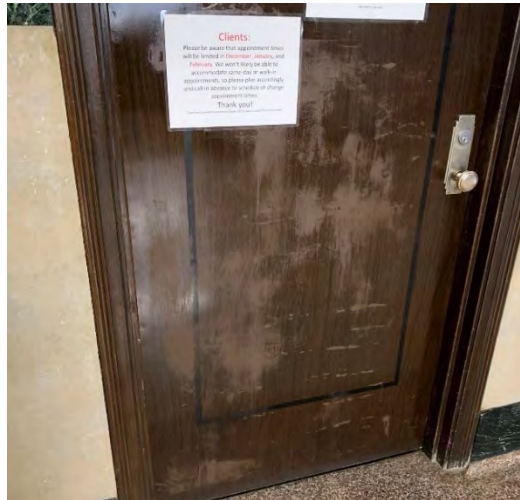
*Figure 9: custom painted doors that will be repainted to match existing*

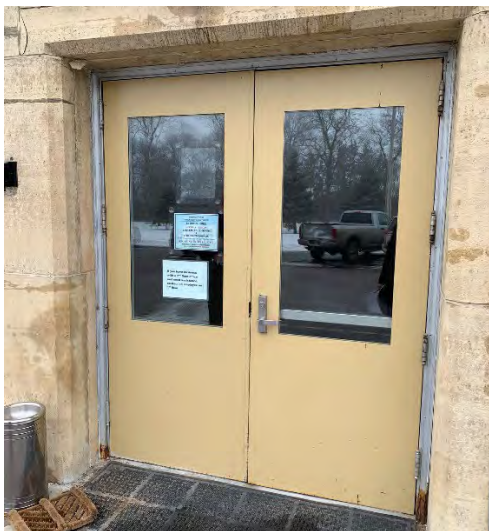
*Figure 10: North set of exterior doors to be replaced*

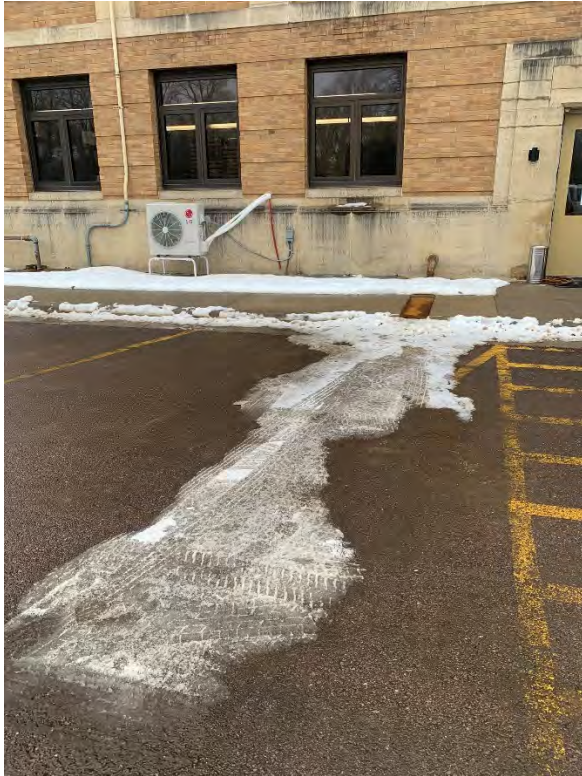
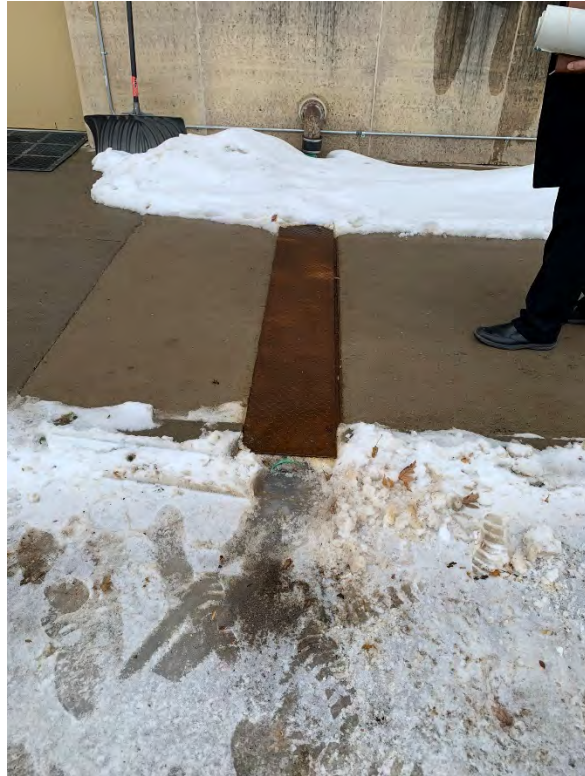
*Figure 11: ice build-up on the Northside of the building*

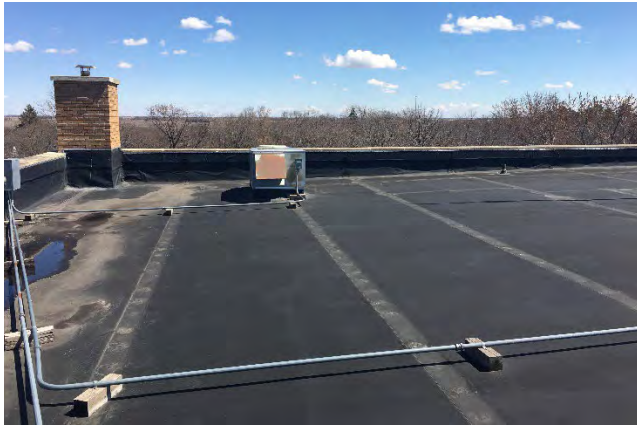
*Figure 13: roof overall*

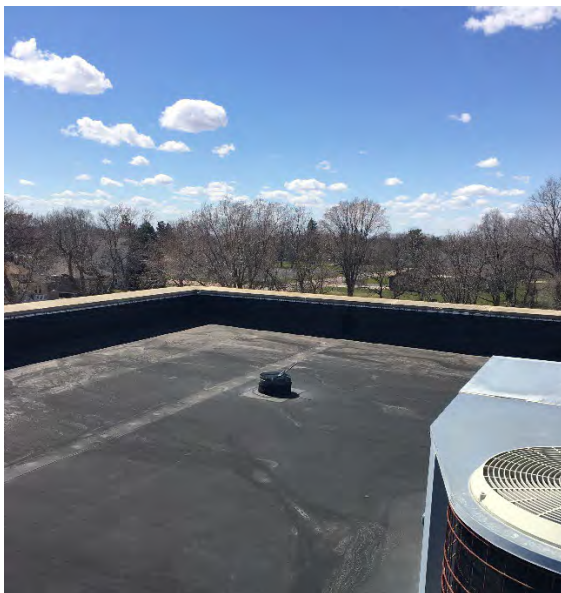
*Figure 15: missing vent turbine*

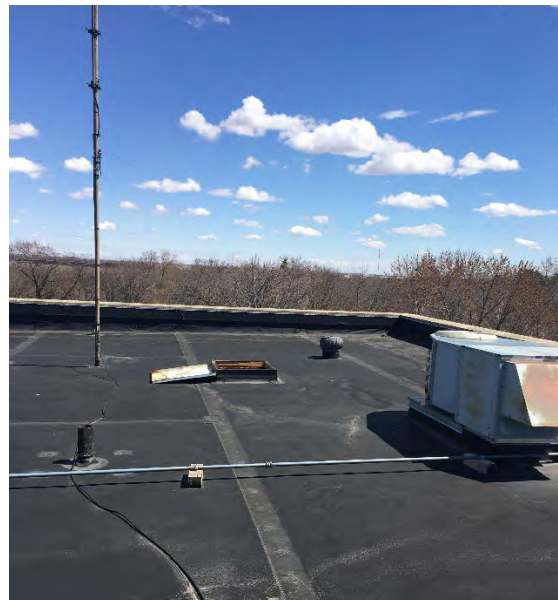
*Figure 16: damaged vent turbine*

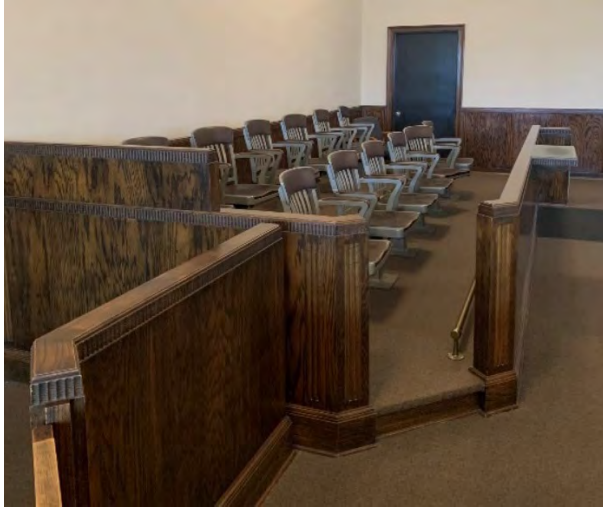
*Figure 18: seating for Jury*

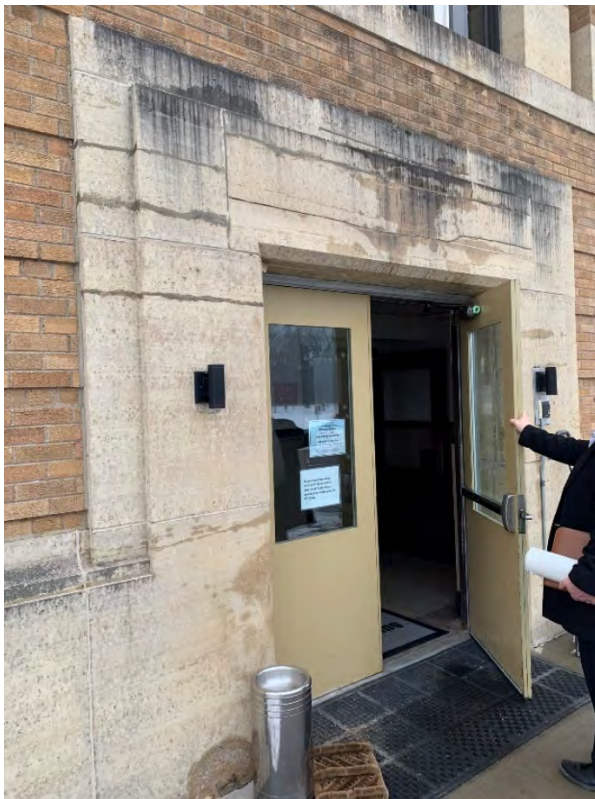
*Figure 26: Water issues at stone lintel*

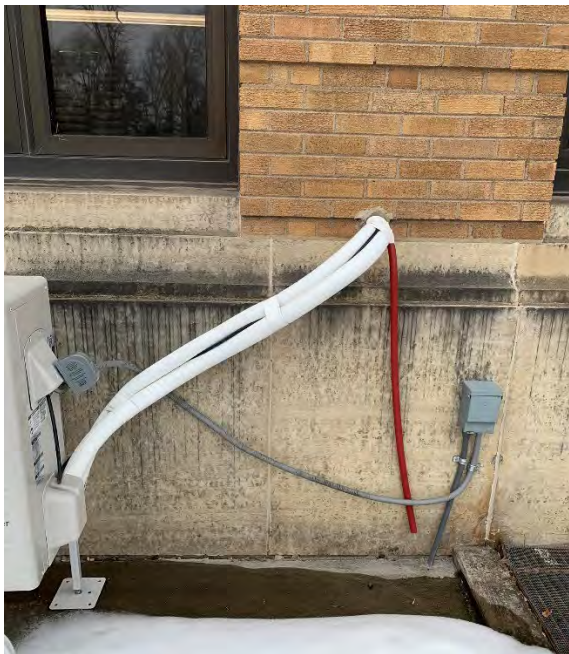
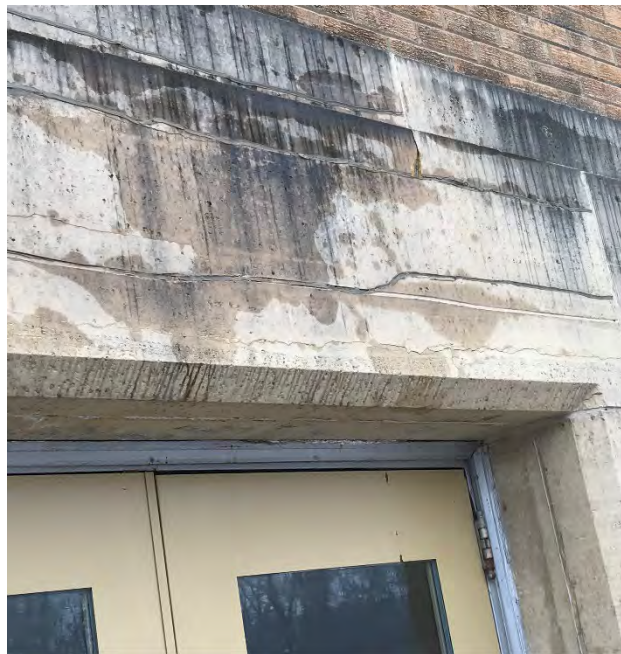
*Figure 30: exterior penetrations for existing mini-split units*

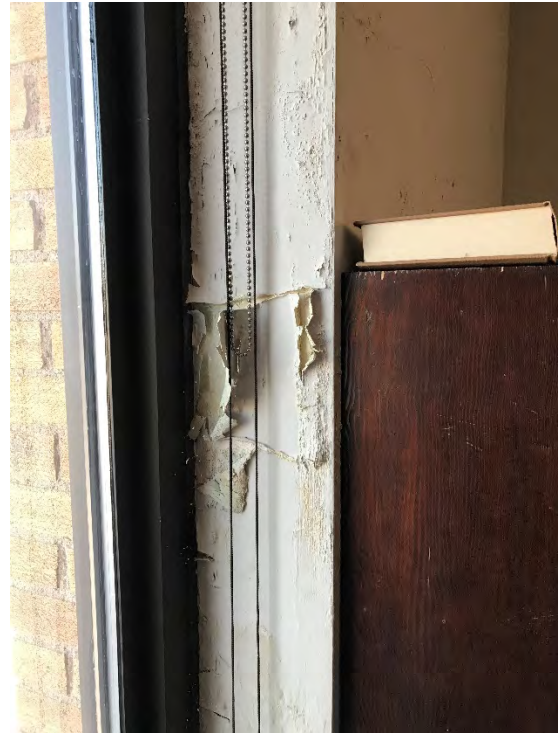
*Figure 37: deteriorating finishes at the window in the evidence room, level 3*

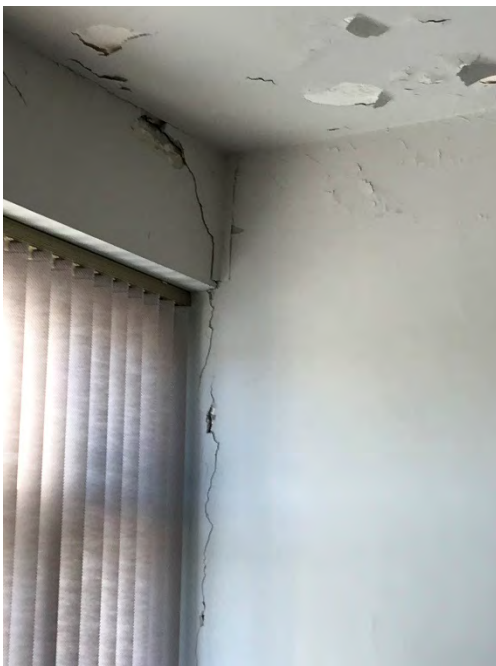
*Figure 38: deteriorating walls in the evidence room, level 3*

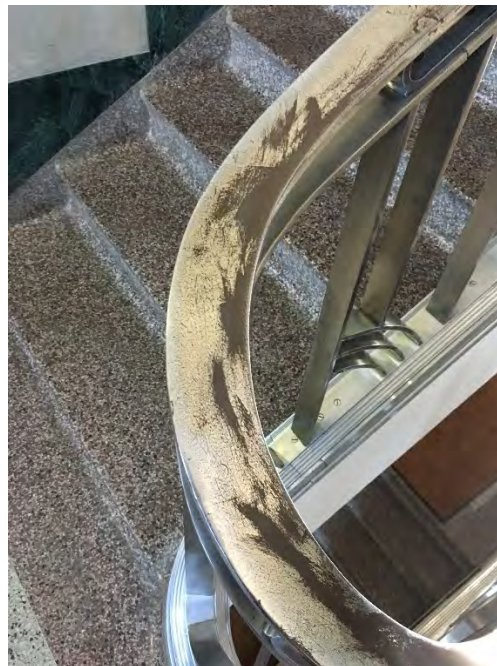
*Figure 39: handrail finish has worn away*

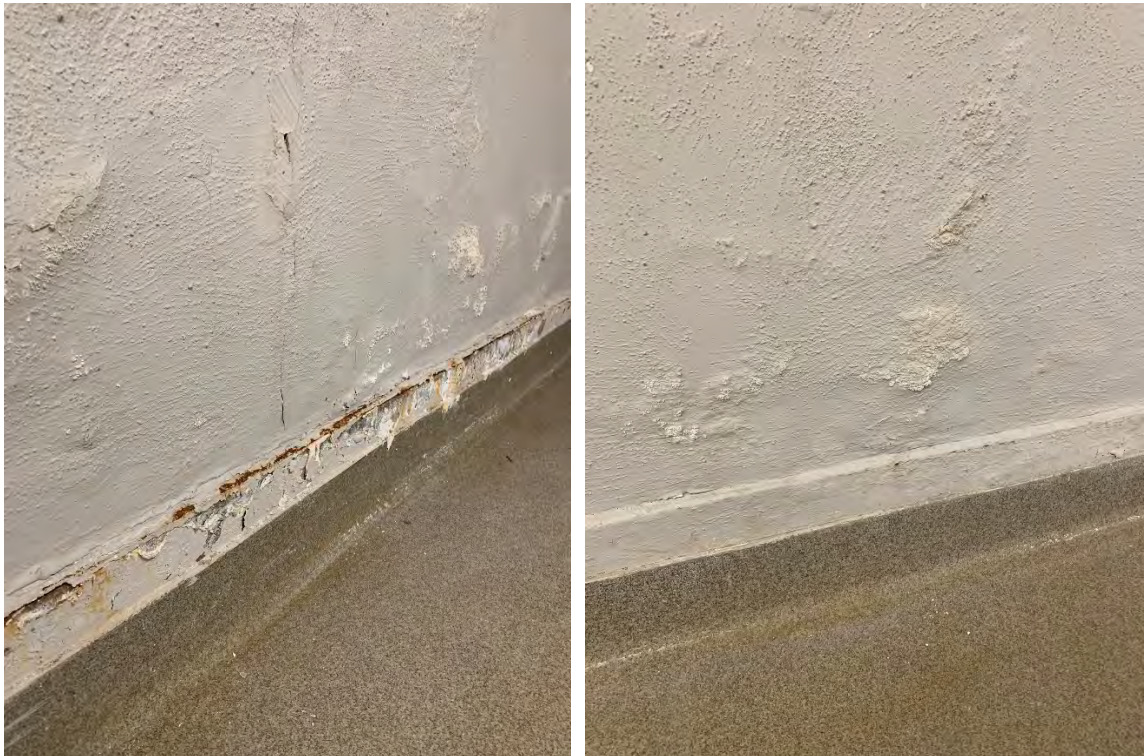
*Figure 41-42: Water issues at the basement wall base: bubbling, cracking*

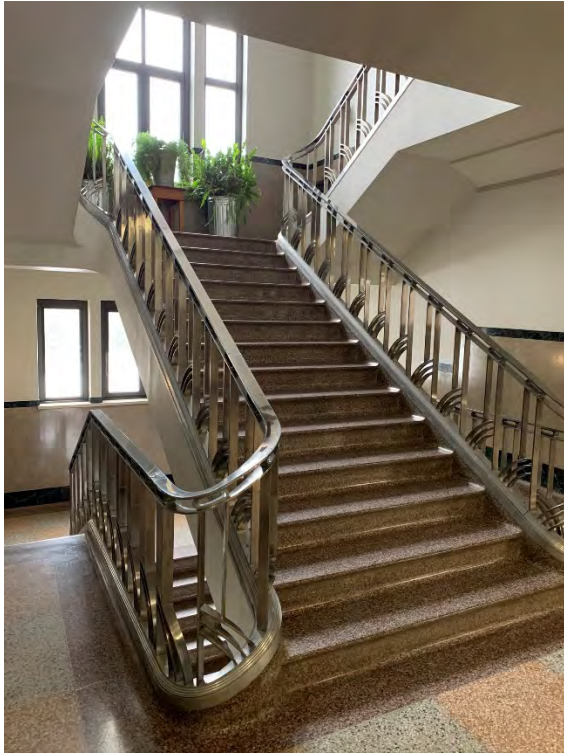
Figure 43: stairwell with original handrail

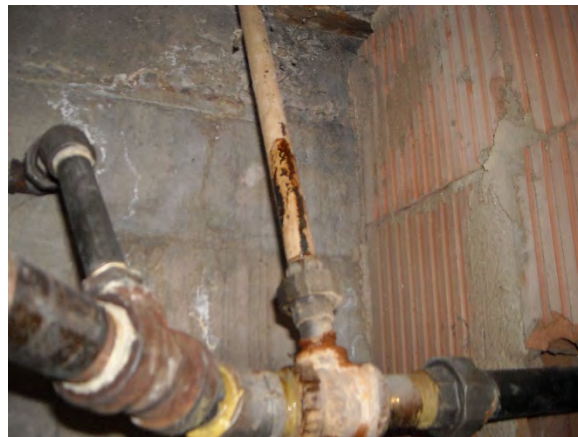
Figure 6 Leaking Steam Return Piping

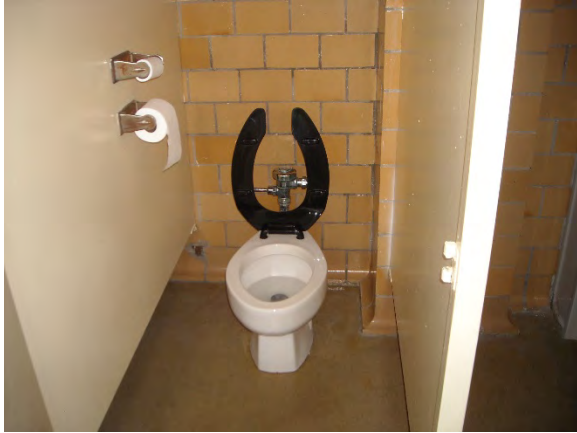
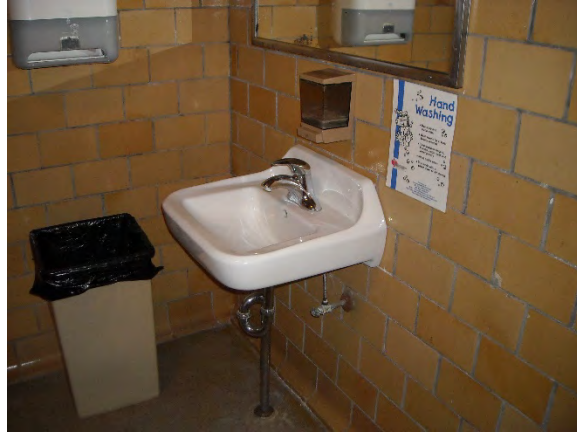
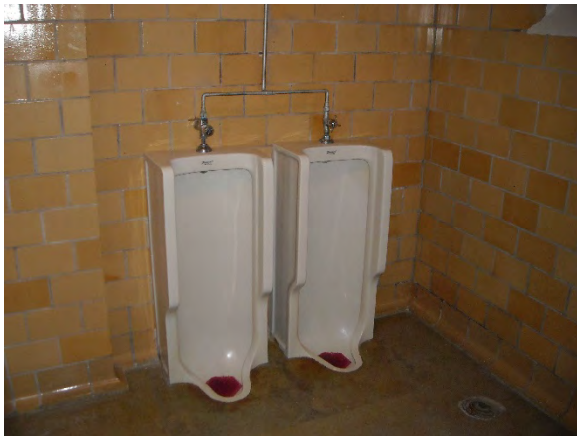
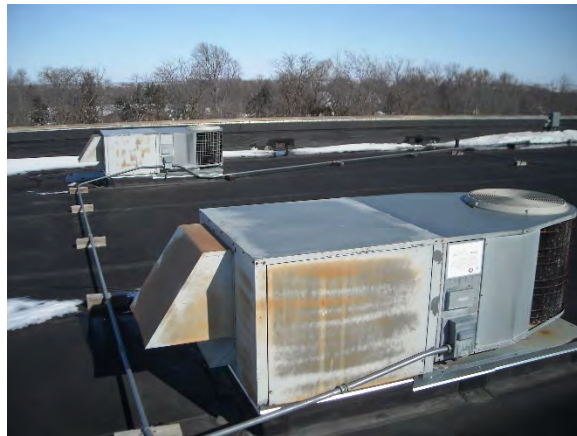
Figures 6, 7, 8 Plumbing Fixtures
